Rapid Ecological Assessment of Sponge and Associated Marine Communities Post Dredging in Tauranga Harbour Entrance

Refining New Zealand

Client Report 16/12/2016

Report Number 2016-02-TGAH

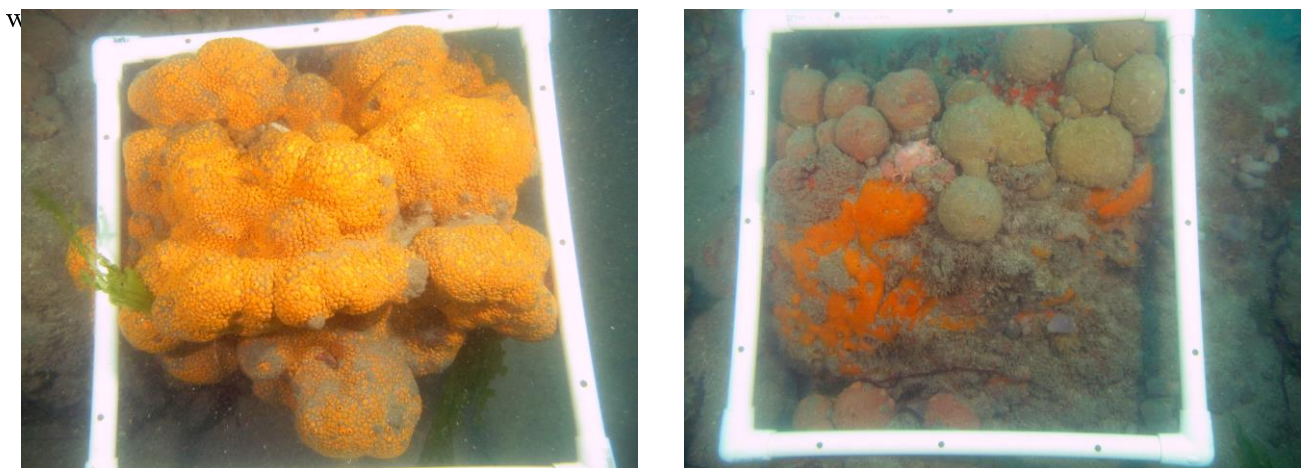
In Tauranga Harbour a diver could expect to find 5 meter visibility on average near the entrance, although this can vary between 0-20 meter depending on rainfall, and recent wave action. At the 15-20 meter depth band light penetration is extremely variable but low, allowing filtering communities such as sponges to dominate. There were no macrophytes present except *Ulva sp.* (sea lettuce) which had drifted and settled. The photos show a high diversity of sponges with encrusting to globose morphology. The strong current limits the extent to which any organism can grow out into the water column from its point of attachment. Also present were brittle stars, a moderate diversity of hydrozoan colonies, colonial and solitary tunicates, *Coscinasterias calamaria* (11 arm starfish), *Patiriella regularis* (cushion starfish), and predatory gastropods. Interestingly, no deposit feeding gastropods were noted, as would expect to be found in a depositional environment. Egg ribbons of hydroid and sponge grazing, nudibranch gastropods

Figure 3. Sponges found in Depth band 1: 15-20m

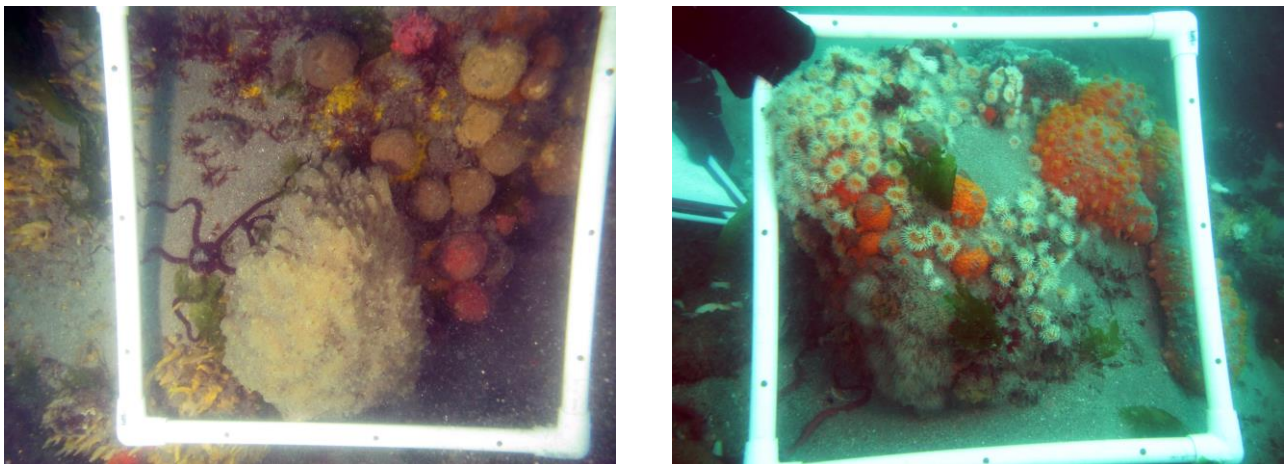
This depth band was very similar to depth band 1 with the appearance of large aggregations of *Anthothoe albocincta* (white striped anemones), and a small variation in diversity of sponges as can be seen in the photos. The average slope is slightly less than depth band 1 with a bit more patchiness and space between hard surfaces. Some small palmate red algae were present as well as *Ulva sp.* that had drifted and settled.

Figure 3. Sponges and White striped anemones found in depth band 2: 10-15m

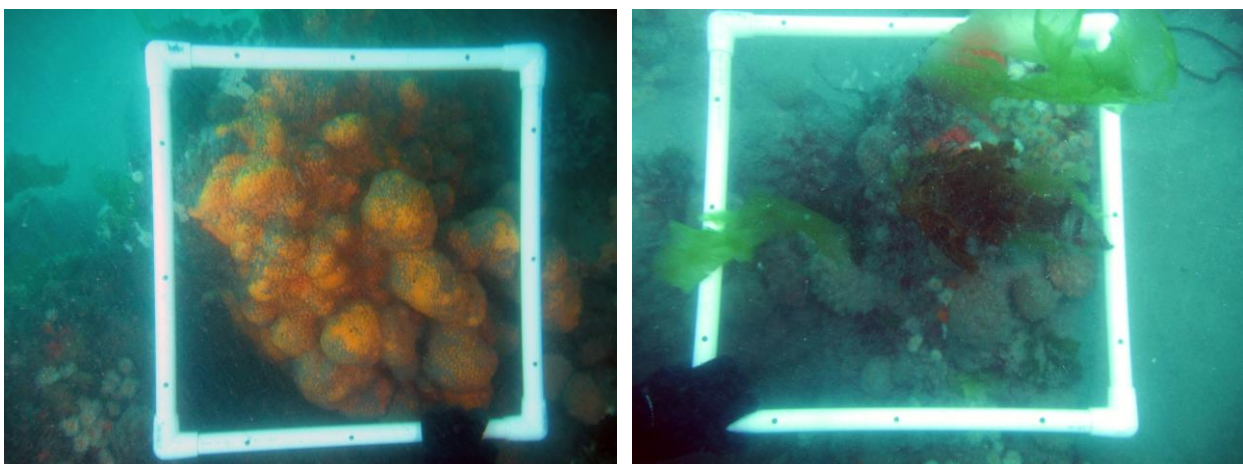
This depth band has a higher light exposure and allows some successful competition by macrophytes. The faunal community is again, sponge and anemone dominated but at roughly 9 meters depth brown algae starts to appear with both *Undaria pinnatifida* and *Ecklonia radiata* present. Small palmate red algae are more common as well as green algae, *Ulva sp.* Some of the *Paphies australis* (pipi) shell wrack that was more common previous to dredging operations appears in the depositional edges of hard surfaces.

Figure 4. Sponges and *Undaria pinnatifida* found in Depth band 3: 5-10m
